S-2420

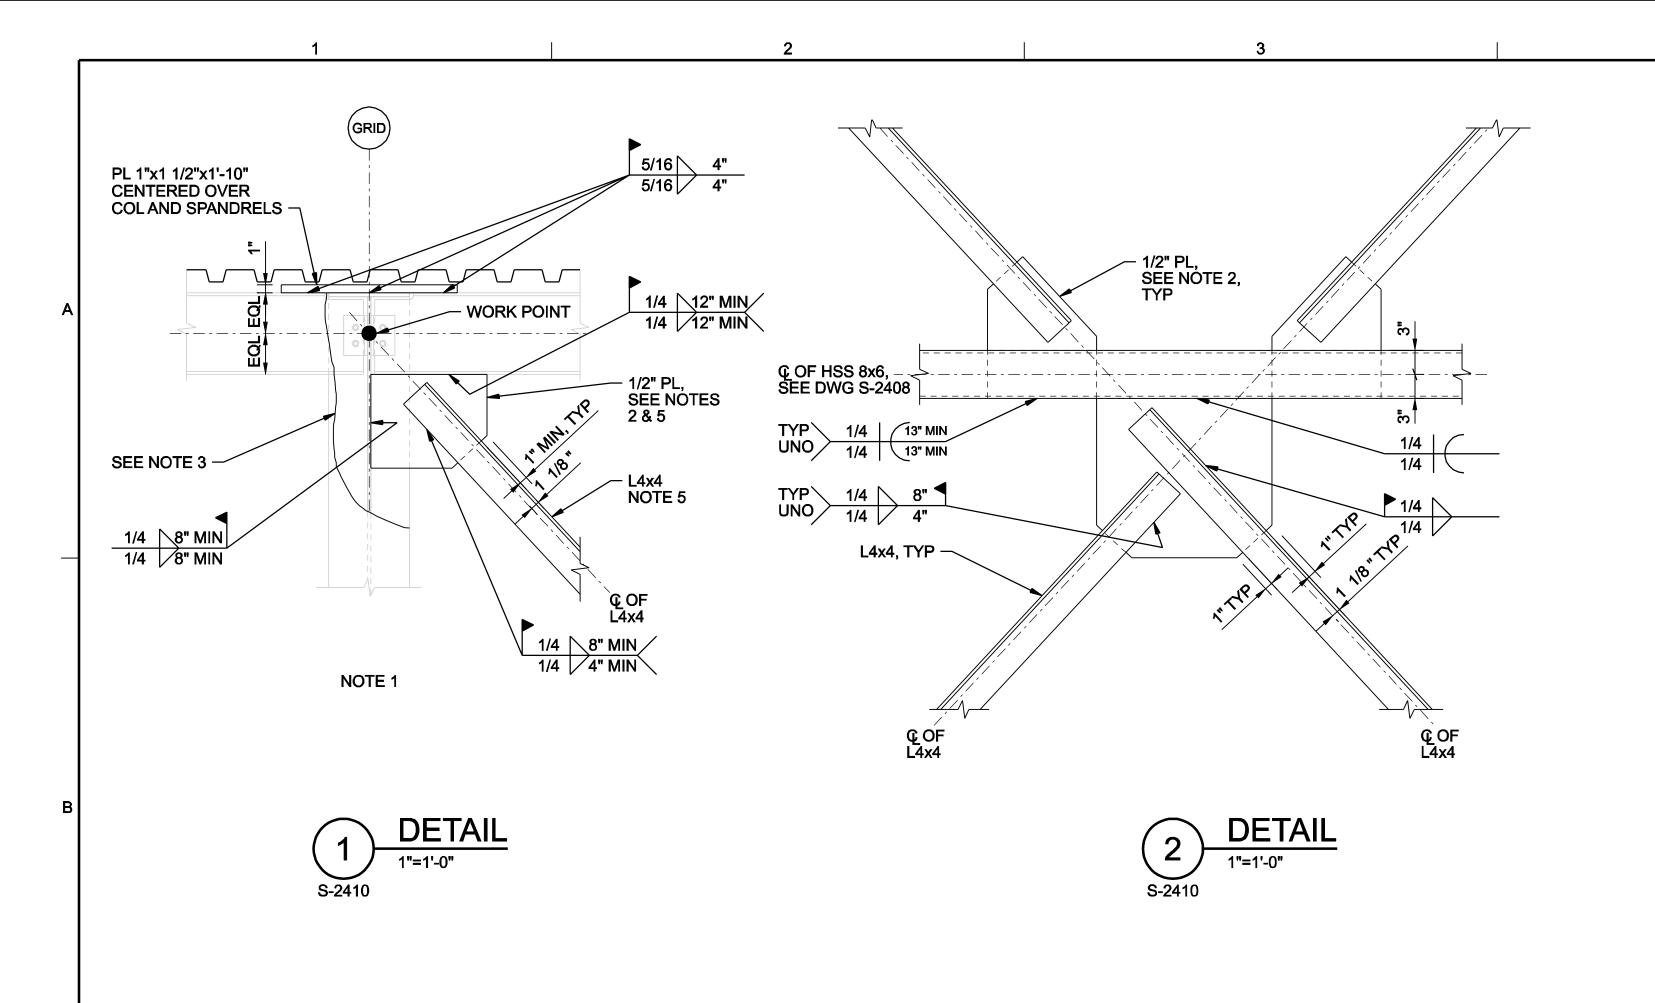
- 1. PARTIAL DEMOLITION OF EXISTING MASONRY REQUIRED. REPAIR MASONRY AFTER WELD PASS INSPECTION.
- 2. NORTH FACE OF PLATE IS 1 1/2" NORTH OF COLUMN GRID 4.
- 3. NEAR FLANGE OF EXISTING COLUMN NOT SHOWN FOR CLARITY.
- 4. WELD OCCURS ON FAR FACE OF COLUMN FLANGE.
- 5. BRACING AND GUSSETS ONLY OCCUR ALONG COLUMN LINE 4.
